NOVEMBER 2019 NEWSLETTER

New Thoughts on Hydrogen Embrittlement of 10.9 Bolts

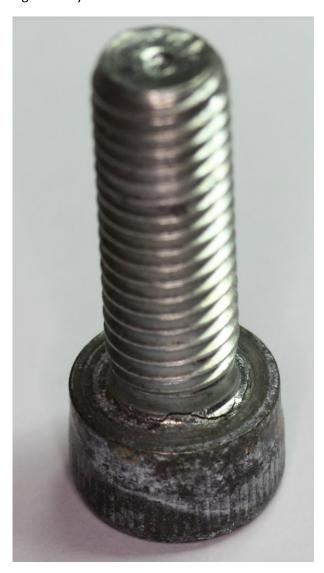
Figure 1 Hydrogen embrittlement of M10 zinc plated SHCS

process). Some fastener specialists are concerned over this change in that, they believe, will significantly increase the risk of HE.
